ROOT CAUSE FAILURE ANALYSIS INVESTIGATION REPORT

Weymouth Compressor Station September 11, 2020 Closure Seal Failure

**Algonquin Gas Transmission, LLC
Subsidiary of Enbridge Inc.**

Report No.: 10263555-1, Rev. 0

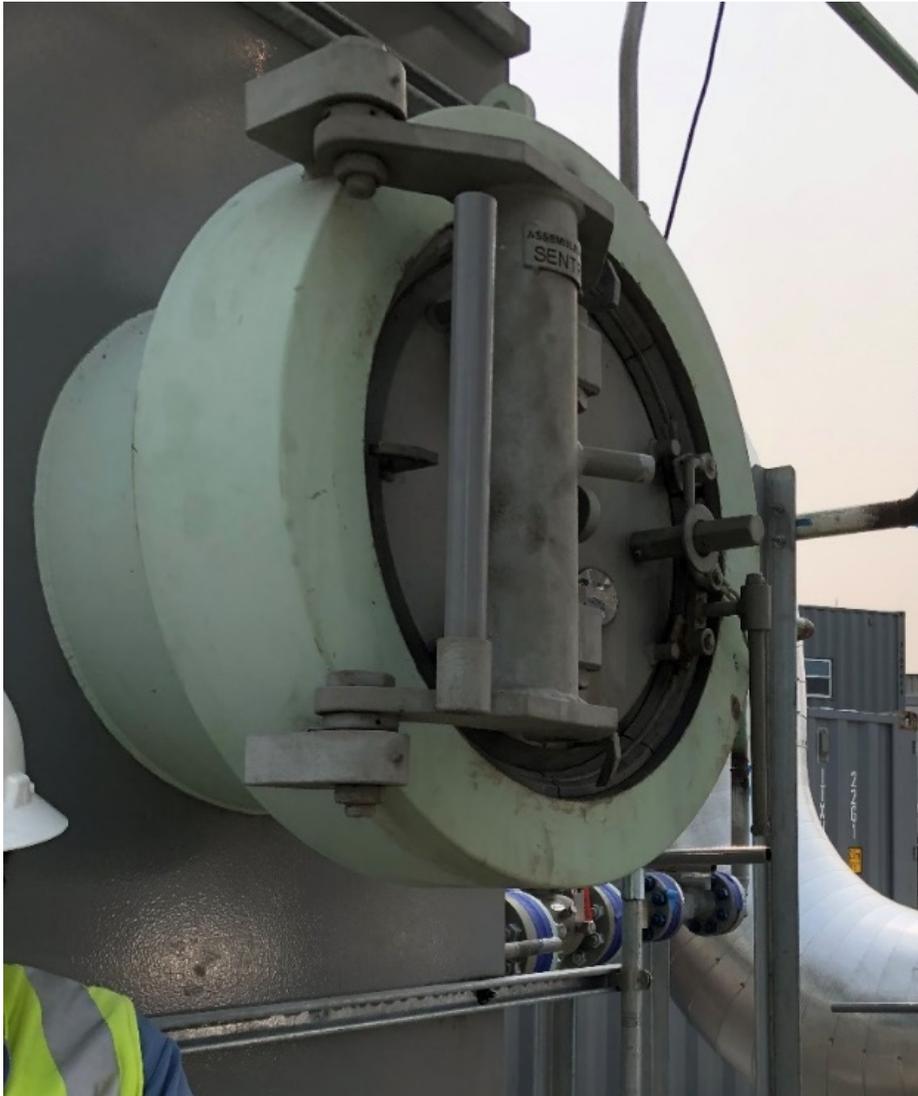
At 8:45 am, the seal for the sump closure door on filter separator FS-01 failed, releasing high pressure natural gas from a localized area between the filter separator closure hub and mating door. Figure 4 is a photograph taken by AGT showing the closure door that experienced the seal failure. A total volume of 169 MSCF of natural gas was released (13 MSCF released at ground level, 156 MSCF released through the source control silencer). Immediately after the seal failure, onsite personnel manually closed the filter separator inlet valve FSI-01 and outlet valve FSO-01 to isolate FS-01 and isolate the release location; however, valve closure could not be confirmed, because of the proximity of the release to the valve position indicators. Therefore, the release area was evacuated at 8:48 a.m. and by 8:50 a.m. it was determined that it was

Approximately 15 minutes later, at 9:05 a.m., personnel identified the likely release origin as the sump closure seal on filter separator FS-01. Filter separator FS-01 was depressurized at 9:30 a.m., and by 10:30 a.m., the sump closure door was opened. AGT personnel verified that a black polymer closure seal (O-ring) had failed.

Figure 4. Photograph provided by AGT showing the closure on Filter Separator FS-01 that experienced a seal failure.

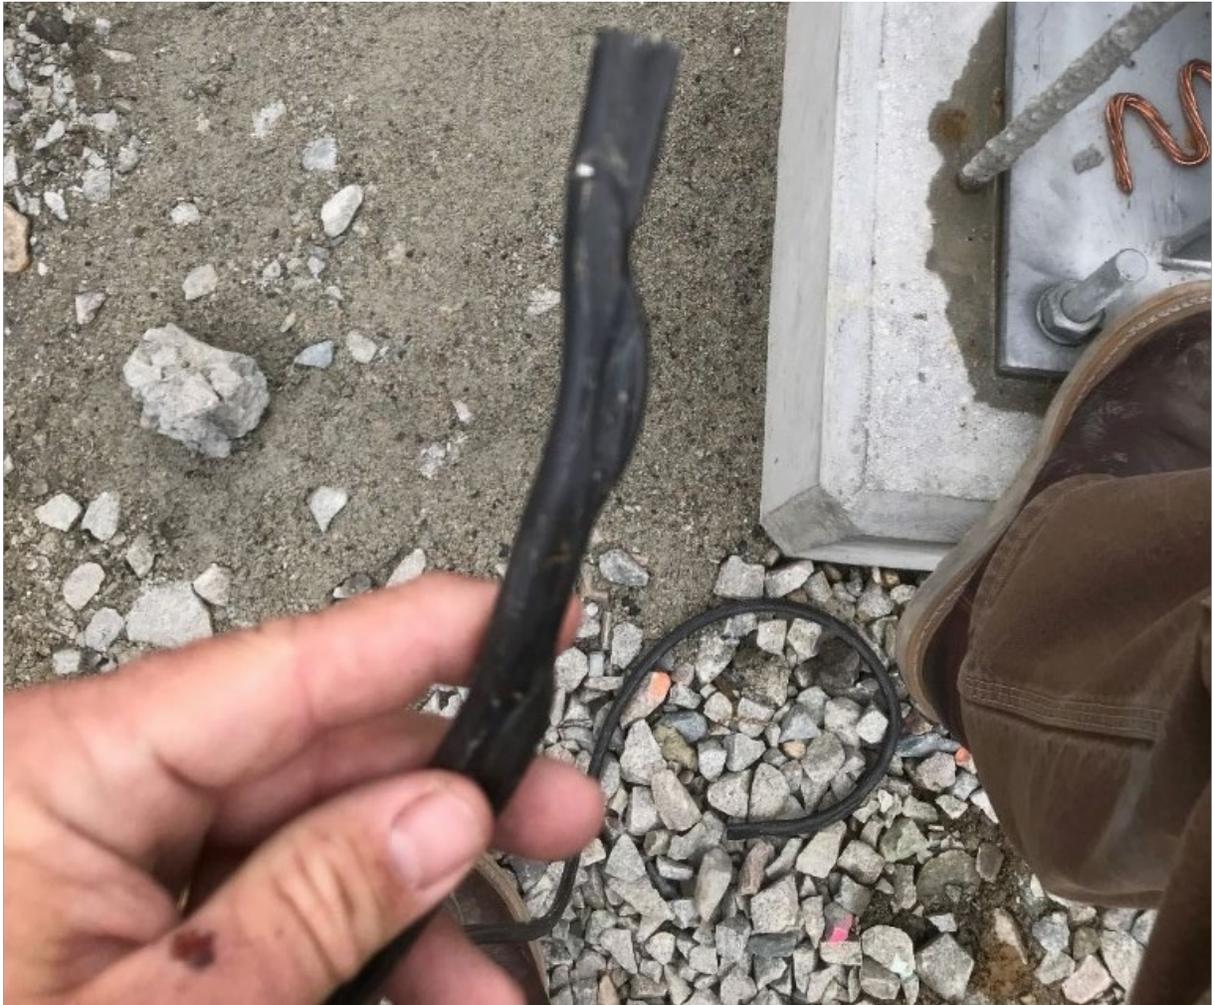
| Observations | Description | Verification |
|---|---|---|
| Direct Cause | The direct cause for the release was determined to be a failed seal on a closure door of a filter separator sump, which was later determined to have a temporary low-pressure O-ring in place, which was not intended for use at full operational pressure or service conditions. | Observations |

AGT initiated an investigation following the event to determine the cause of the loss of containment at the sump closure. The investigation determined that the seal (O-ring) that was in place during commissioning was not intended to experience operational pressure or in-service environments. The operational seal, intended for service, was shipped at the same time as the filter separator but was not installed. It was AGT's belief that the vessels were delivered with operational seals installed based on the experience of the AGT personnel onsite. As the unit was brought online, the O-ring experienced failure at a pressure of 579 psig. Figure 5 is a photograph showing the failed O-ring following opening of the closure door and removal of the O-ring. The O-ring exhibits a wavy pattern with areas that are flattened. Figure 6 is a photograph showing a similarly damaged O-ring on one of the sump closures of Filter Separator FS-02 following opening of the closure door. The O-ring exhibits the same characteristics as the failed O-ring on FS-01. Desiccant packs can also be seen inside the sump of FS-02.

The DNV GL investigation team reviewed photographs and other relevant information and verified the direct cause of the loss of containment was failure of the seal on the filter separator sump door closure. As part of DNV GL's investigation, interviews were conducted to identify the barriers in place at the time of the event, determine their effectiveness, establish root causes of any ineffective barriers, and suggest recommendations for continuous improvement.

Figure 5. Photograph provided by AGT showing the failed O-ring.

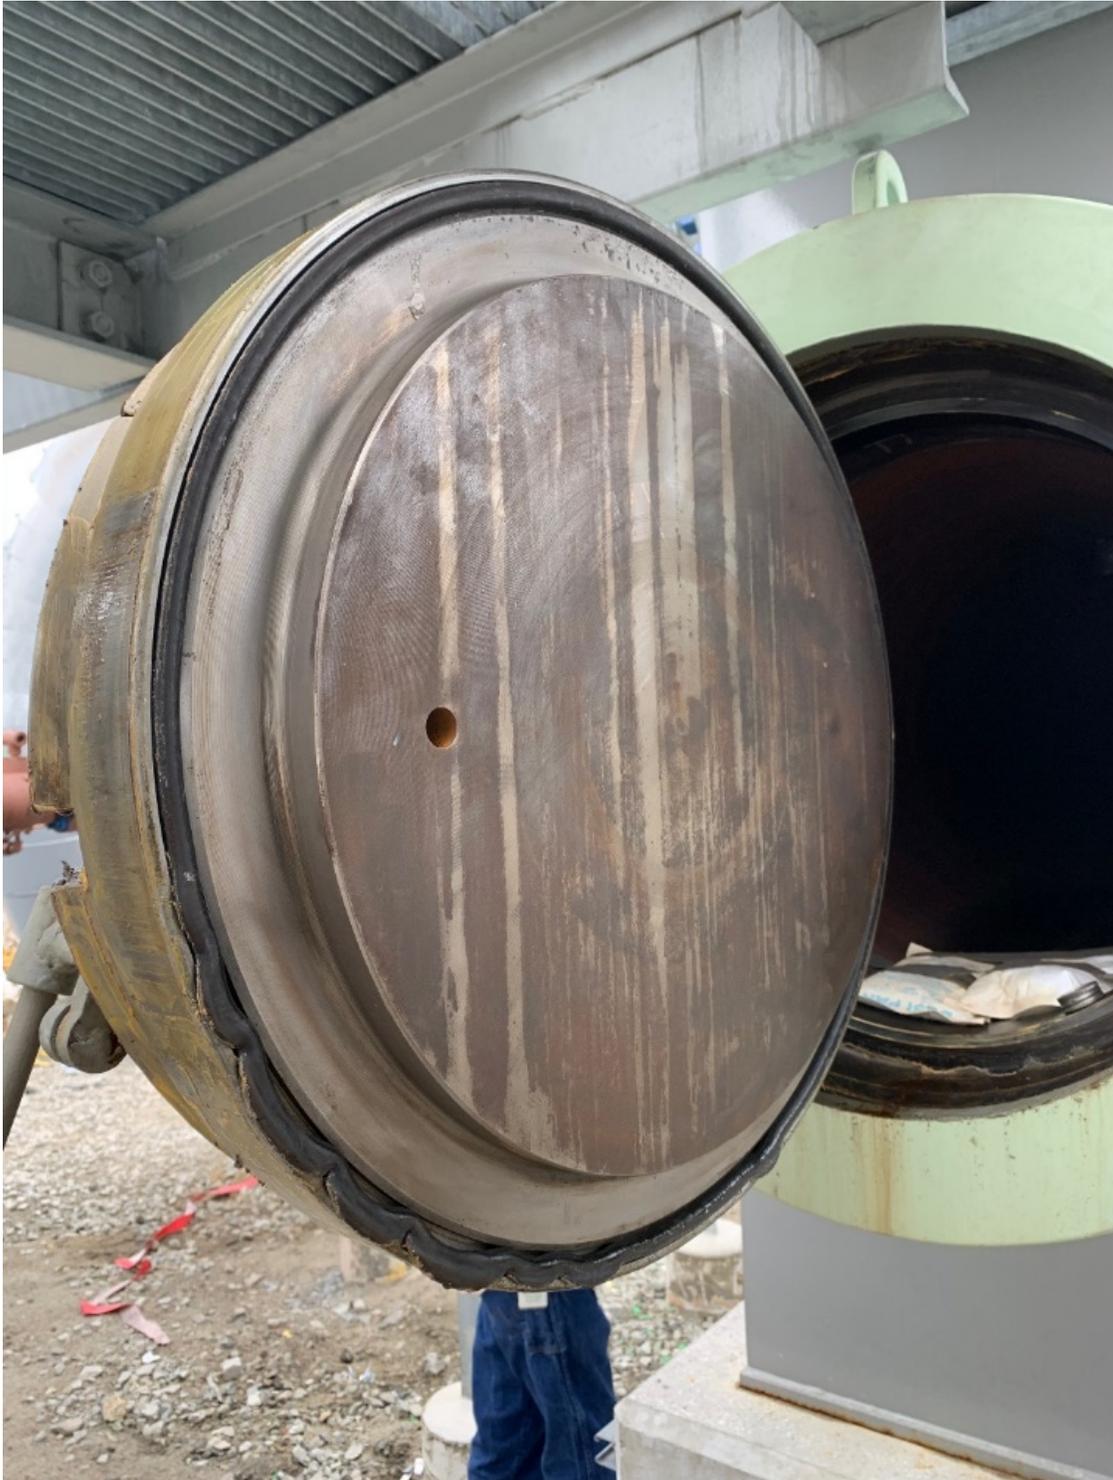
Figure 6. Photograph provided by AGT showing a similarly damaged O-ring on a closure door of Filter Separator FS-02. Desiccant packs can also be seen inside the closure hub.
